This inspection report performed by MK & Associates, Inc (MK) was conducted in accordance of the Wisconsin state standards and practices. It is intended to identify deficiencies, issues, normal wear and also provide suggestions. Not all deficiencies or problems will be identified. Unexpected repairs should still be anticipated.

Sample Report

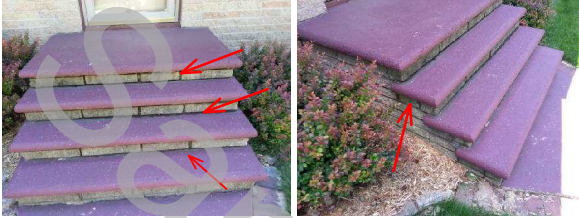
1. ☒ ☐ ☐ ☐ ☐ Driveway: Concrete
2. ☒ ☐ ☐ ☐ ☐ Walks: Concrete
3. ☐ ☒ ☐ ☐ ☐ Steps/Stoops: Concrete, Brick // Repair brick/joints on stoop

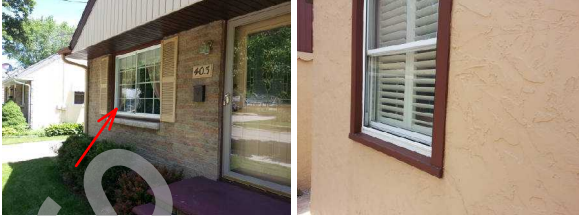
11. ☒☒☐☐☐ Storm Windows/Screens: Screens part of windows // missing on front window

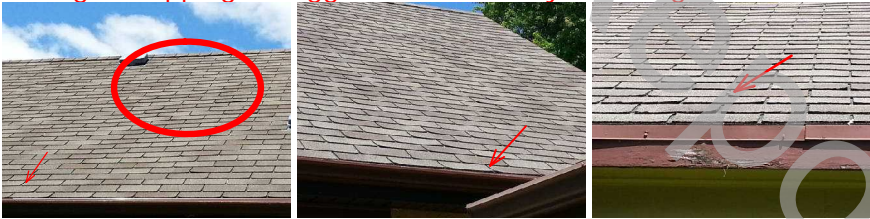
1. Method of Inspection: Ground level
2. ☐☐☒☐☐ Roof Condition: Fiberglass shingle // **Roof exceeding past typical life expectancy. Signs of curling or cupping. Suggest evaluation by a roofing contractor.**

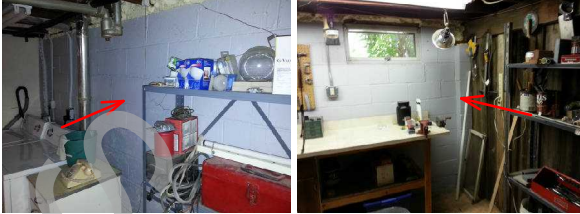
2. ☐ ☒ ☐ ☐ ☐ Foundation Walls: Poured Concrete // Horizontal Cracks and wall has some deflection. Wall has deflected under 1". Monitor. Rectify if movement continues.

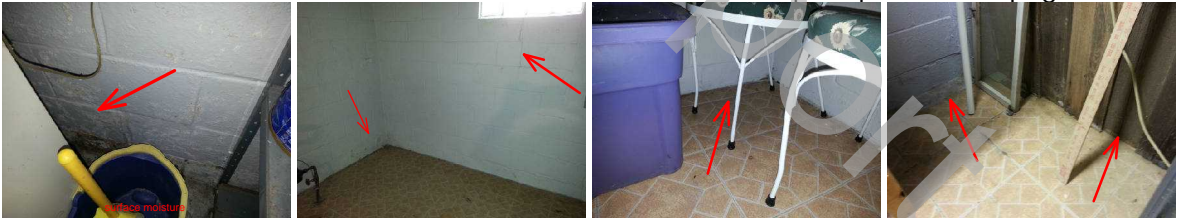
1. ☐ ☐ ☐ ☒ ☐ Unable to Inspect: 25%, Foundation walls // Covered walls, Storage shelves
 2. ☒ ☐ ☐ ☐ ☐ Basement Stairs/Railings: Carpet covered stairs with wood rail
 3. ☒ ☐ ☐ ☐ ☐ Floor: Vinyl floor covering // some missing
 4. ☒ ☐ ☐ ☐ ☐ Floor Drain: Surface drain
 5. ☒ ☐ ☐ ☐ ☐ Walls: Block
 6. ☐ ☒ ☐ ☐ ☐ Moisture Location: None at this time // Evidence indicates past/present seepage

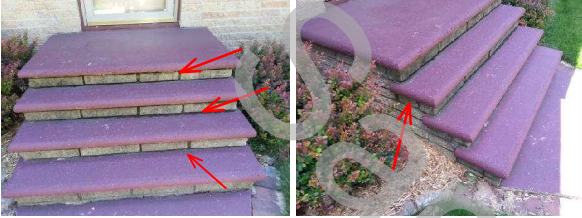
1. Steps/Stoops: Concrete, Brick // Repair brick/joints on stoop

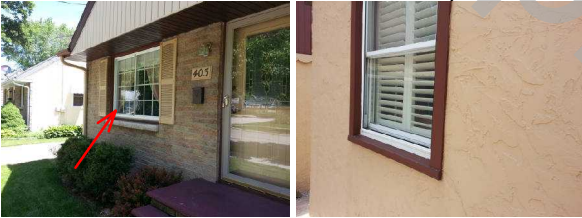
2. All Exteriors Exterior Surface Type: Brick veneer, Stucco // Stucco siding is like a concrete exterior. Maintain and seal cracks to reduce water related damages to surface.
3. Storm Windows/Screens: Screens part of windows // missing on front window

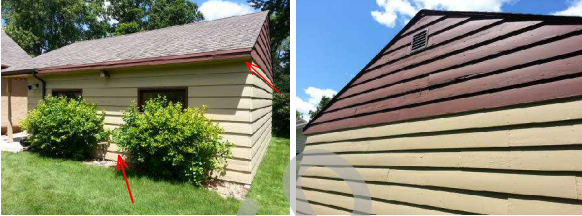
Exterior Surface (Detached): (continued)

9. Detached Garage Exterior Surface (Detached): Wood siding, wood fascia // Peeling paint noted, Deterioration. garage in need of some maintenance

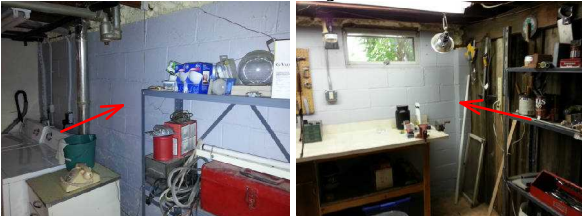
22. Foundation Walls: Poured Concrete // Horizontal Cracks and wall has some deflection. Wall has deflected under 1". Monitor. Rectify if movement continues.

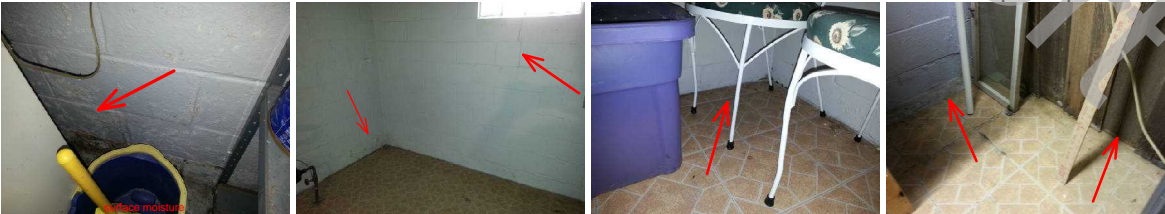
23. Main Basement Moisture Location: None at this time // Evidence indicates past/present seepage

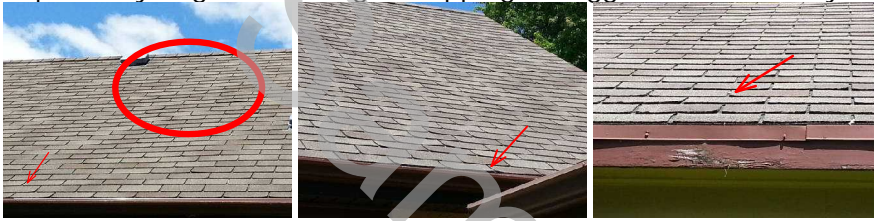
1. House, Garage Roof Surface Roof Condition: Fiberglass shingle // Roof exceeding past typical life expectancy. Signs of curling or cupping. Suggest evaluation by a roofing contractor.
